Mechanical Engineering Technical Memorandum 409

**RESULTS OF T56 ENGINE PERFORMANCE MONITORING TRIAL  
IN HERCULES AIRCRAFT, FEBRUARY-JULY 1977**

D.E. GLENNY

APRIL 1981

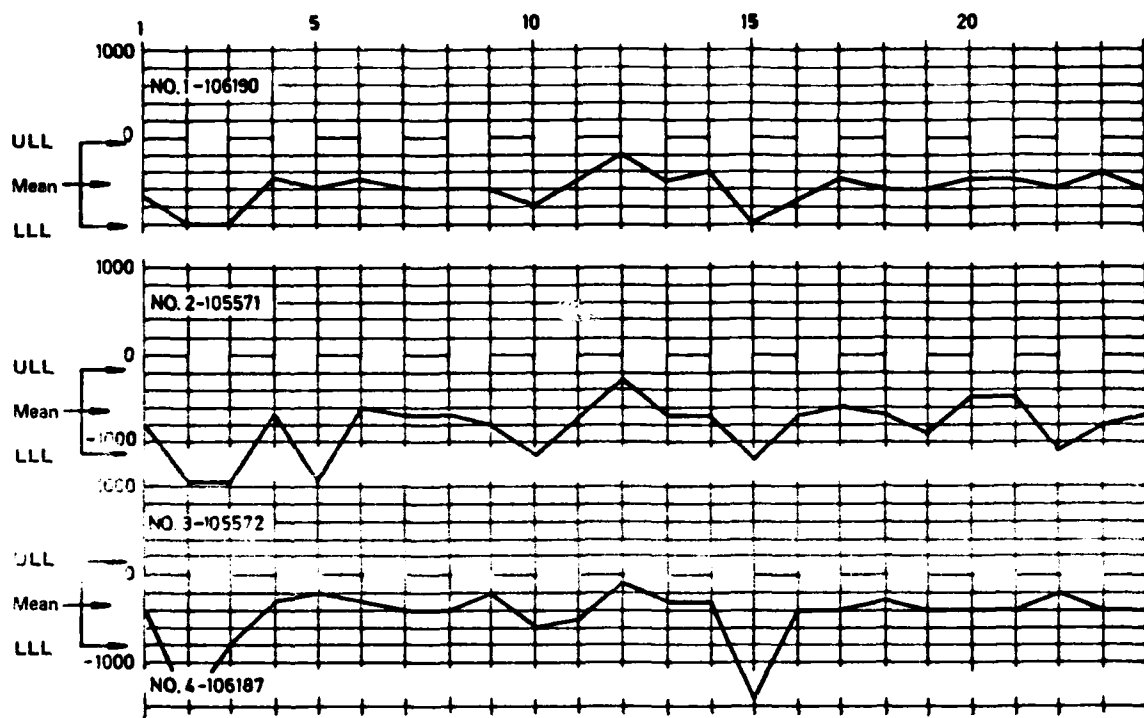
FIG. 1 TORQUE TRENDS

The number 4 engine on this aircraft was consistently reported for high levels of torque and fuel flow in comparison with the other three engines; this fact is confirmed by the trend plots given in Fig. 1, which consistently show low levels of torque for engines 1, 2, 3 (and fuel flow - not given), indicating high torque values for engine number four. The results of the defect investigation for this engine are not known, but the problem is most probably associated with the temperature indicating system.

Consistently low values of torque (and fuel flow) for engines 1, 2 and 3 during the total period of the monitoring trial. Engine No. 4 periodically reported for high torque and high fuel flow with low TIT indication. Finally rejected and returned to Qantas.

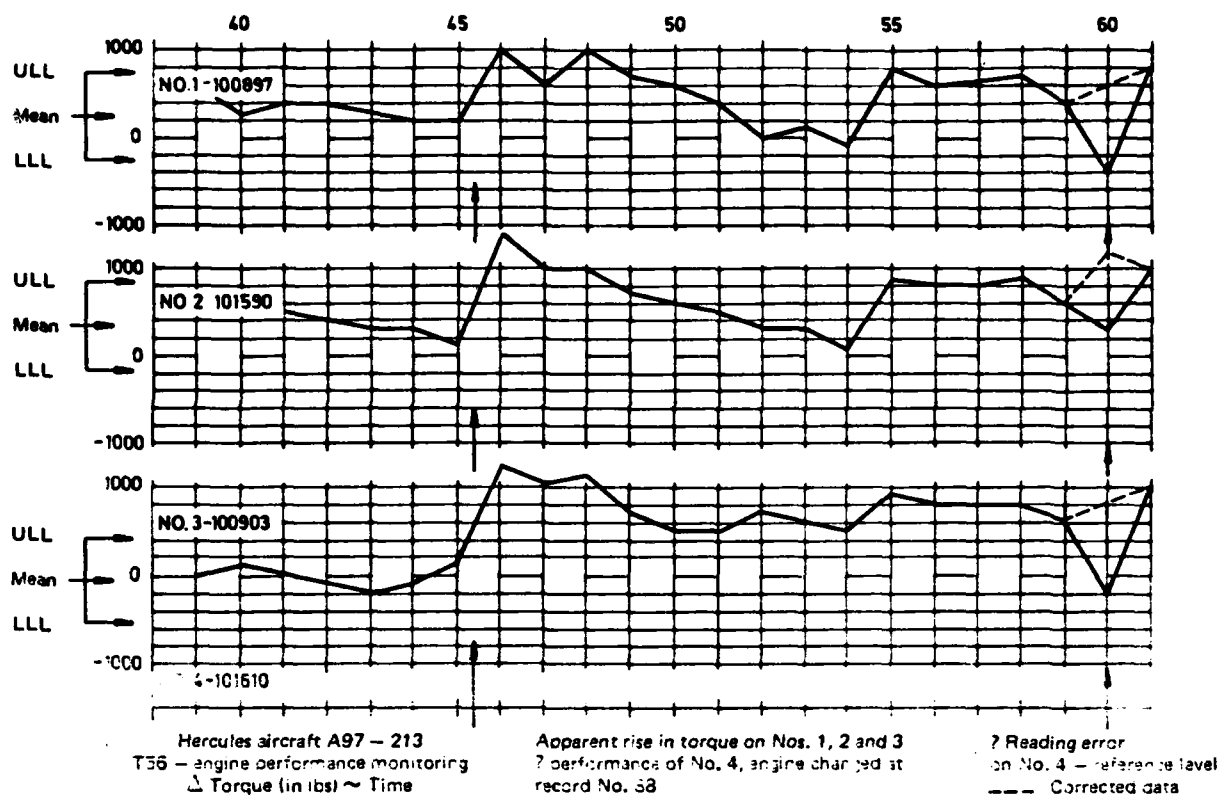
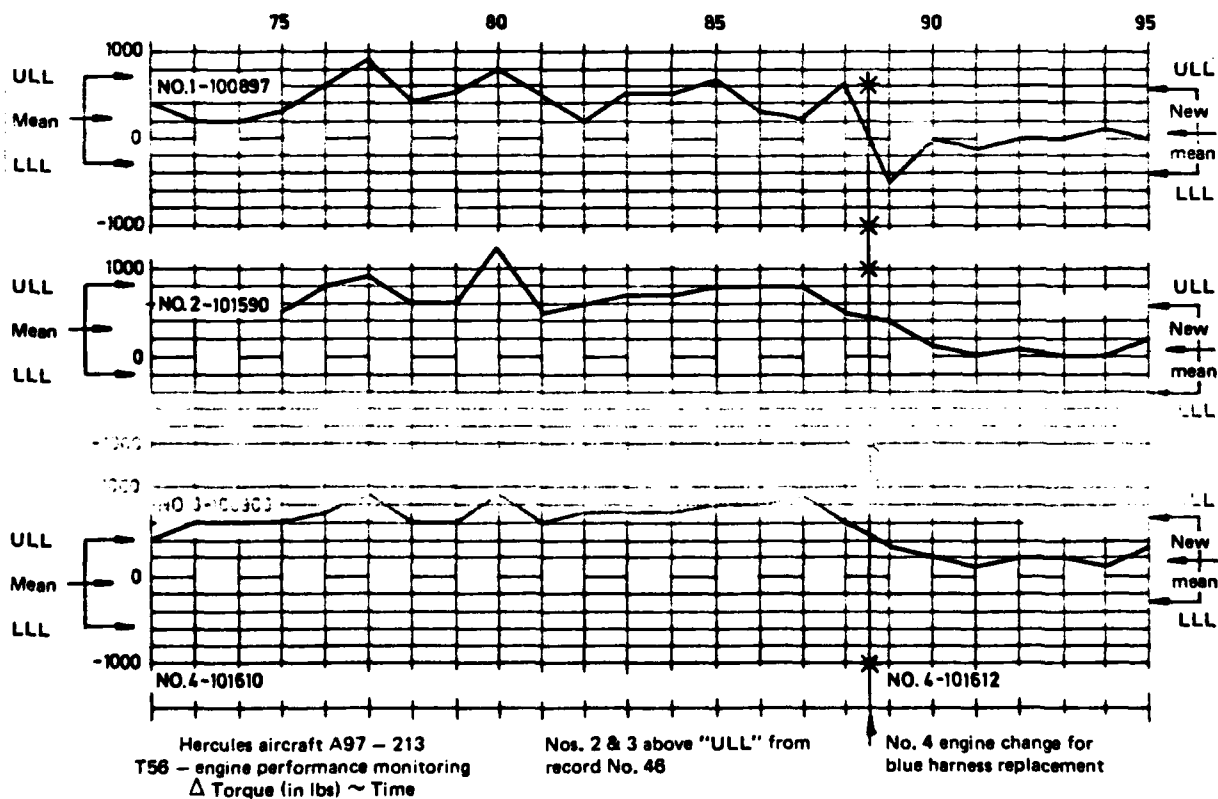
FIG. 2 TORQUE TRENDS

In comparison to the performance of engine number 4, high levels of torque and fuel flow were continually being reported on engines 1, 2 and 3. Maintenance action on engine 4, subsequent to its removal from the aircraft, indicated that a faulty harness leading to the Temperature Datum amplifier was giving an over reading of the turbine inlet temperature. This fault would result in low indicated torque and fuel flow values for that engine, or conversely the apparent high trend values for the performance of engines numbers 1, 2 and 3. Examination of the torque trends for

this aircraft, given in Fig. 2, indicates a sudden increase in torque level at point 46; the original torque level is restored at point 88, after the faulty harness had been replaced and the engine reinstalled. It should be noted that the original failure was indicated a considerable time before maintenance action had been initiated. (Also shown in Fig. 2 are the effects of a torque misreading at point 60, the corrected trend line is shown dotted).

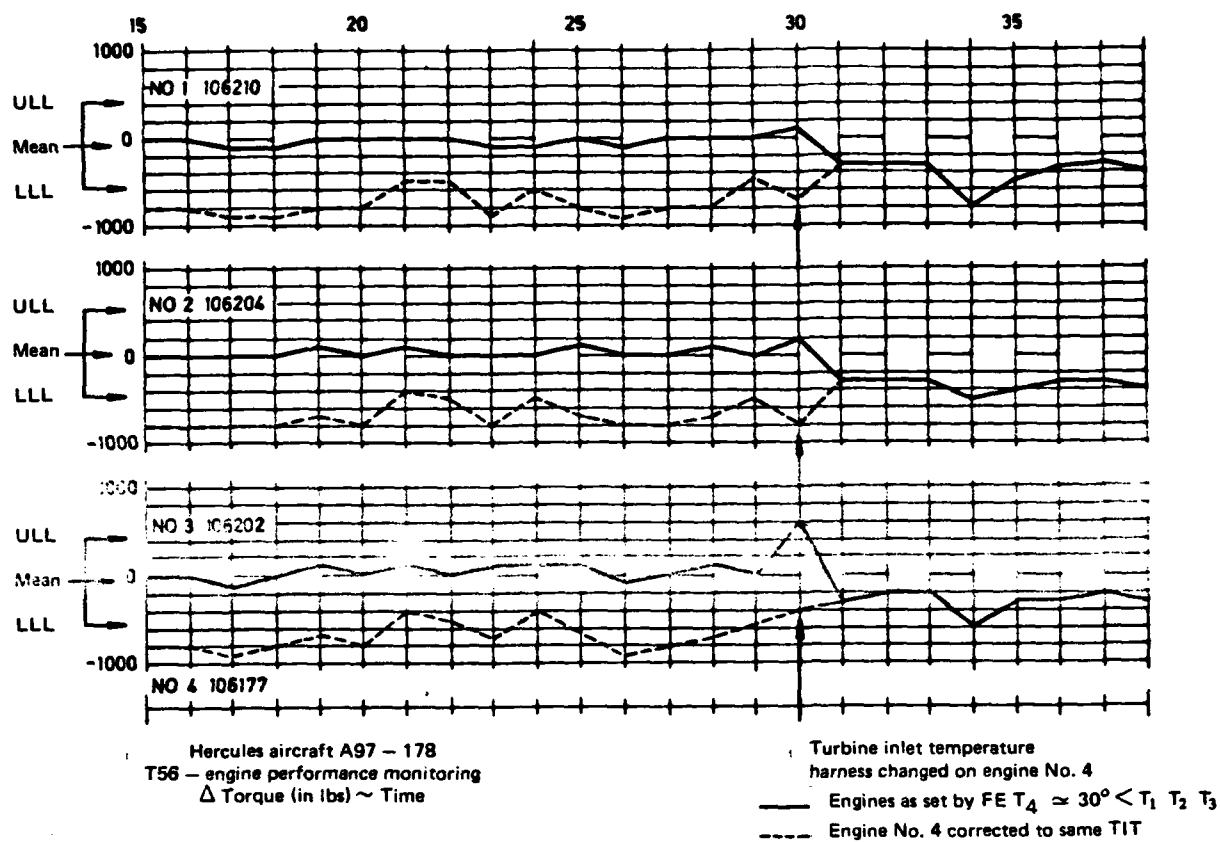
FIG. 3 TORQUE TRENDS

An extract from the torque trend plots for this aircraft is given in Fig. 3 which shows that at point 30 there is a distinct change in the torque levels for engines 1, 2 and 3, indicating a malfunction or change in the operation of the fourth engine. (Similar indications are present on the fuel flow trends). Examination of the flight engineer's raw data prior to point 30 shows that the TIT of the fourth engine had been suppressed by 20-30°C below the value of the other 3, thus maintaining the torque and fuel flow levels of all 4 engines at approximately the same value. Corrected trend plots for the 3 engines obtained by "artificially" increasing the TIT\* of the fourth engine are given by the dotted line, which shows that "correct" torque level for engines 1-3 should have been at least 800 in. lb. below that of engine number 4.

Reference to the EE 500 shows that at point 30 the TIT harness had been changed in an endeavour to correct for the difference in temperature/torque levels. During subsequent engine operation, all TIT's were held at a common value with the result that the torque level of the No. 4 engine is now only 300 in. lb. greater than the average of engines 1, 2 and 3; this difference in levels could be the result of thermocouple deterioration.

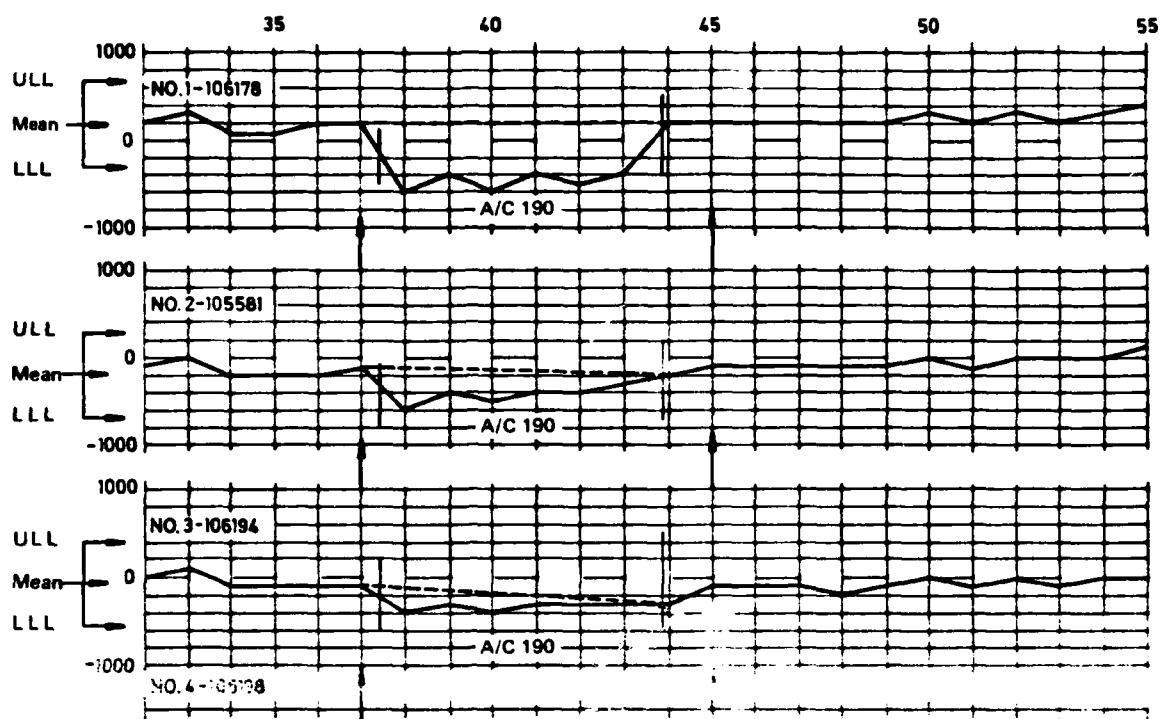
FIG. 4 TORQUE TRENDS

Examination of the torque trends for aircraft 180 given in Fig. 4 shows that between points 37 and 44 there is a sudden drop in torque level for engines 1, 2 and 3, indicating a rise in the output of the fourth engine. Scrutiny of the EE 500's failed to indicate any malfunction associated with the reference engine,

however cross checking the raw data showed that points 38-43 were in fact applicable to aircraft A97-190 and had been inserted in error. Replotting the data with points 37 and 44 sequentially shows that there is no engine fault or change in performance: analysis and plotting of the trends in flight would obviate this error.

- (1) Fall in torque & fuel flow on 1, 2 and 3 possible fault in No. 4 thermocouple or thermocouple.

- (2) On checking data for A/C-180 it was found that results for A/C-190 had been inserted by error. Therefore readings 37-44 should be deleted.

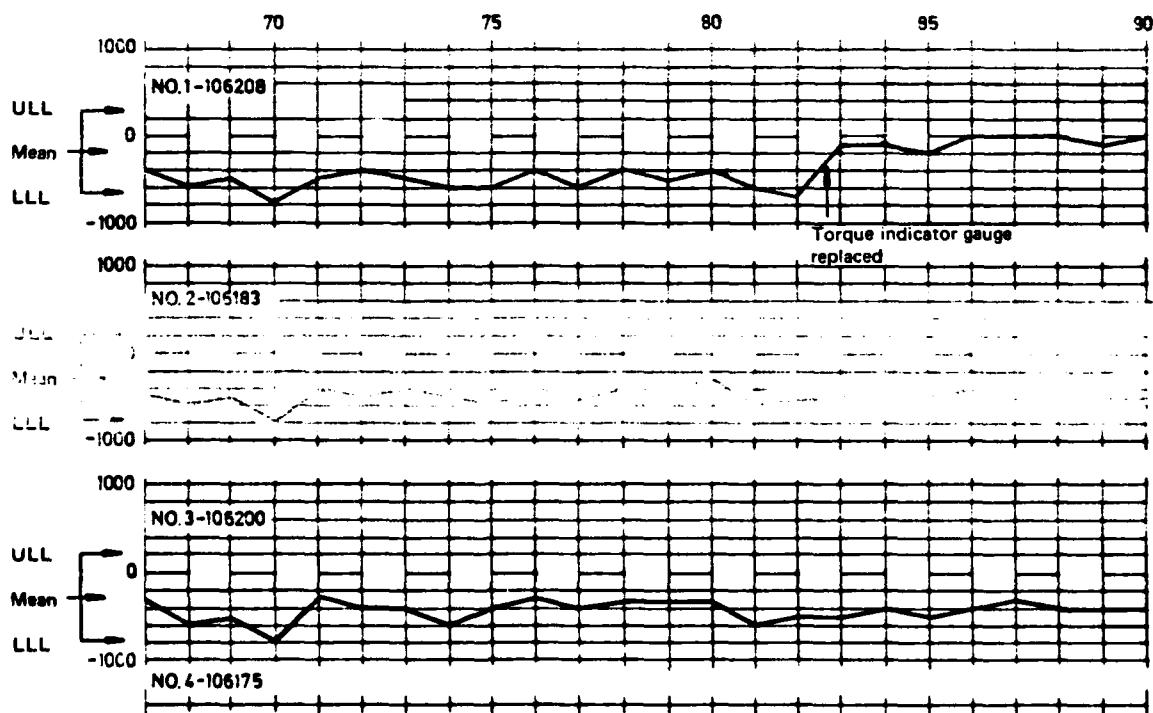
FIG. 5 TORQUE TRENDS

A general survey of the torque plot in Fig. 5 for engine 1 on aircraft 190 indicates that the torque level had been gradually falling, over a period of 6 weeks, until at about point 81 the lower limit line was encountered. At point 83, there is a sudden increase in torque and the 'normal' mean level is re-established. Reference to the EE 500's shows that the torque gauge was replaced between points 82 and 83: it is not known how long the flight engineer had been aware of the problem before reporting this malfunction.

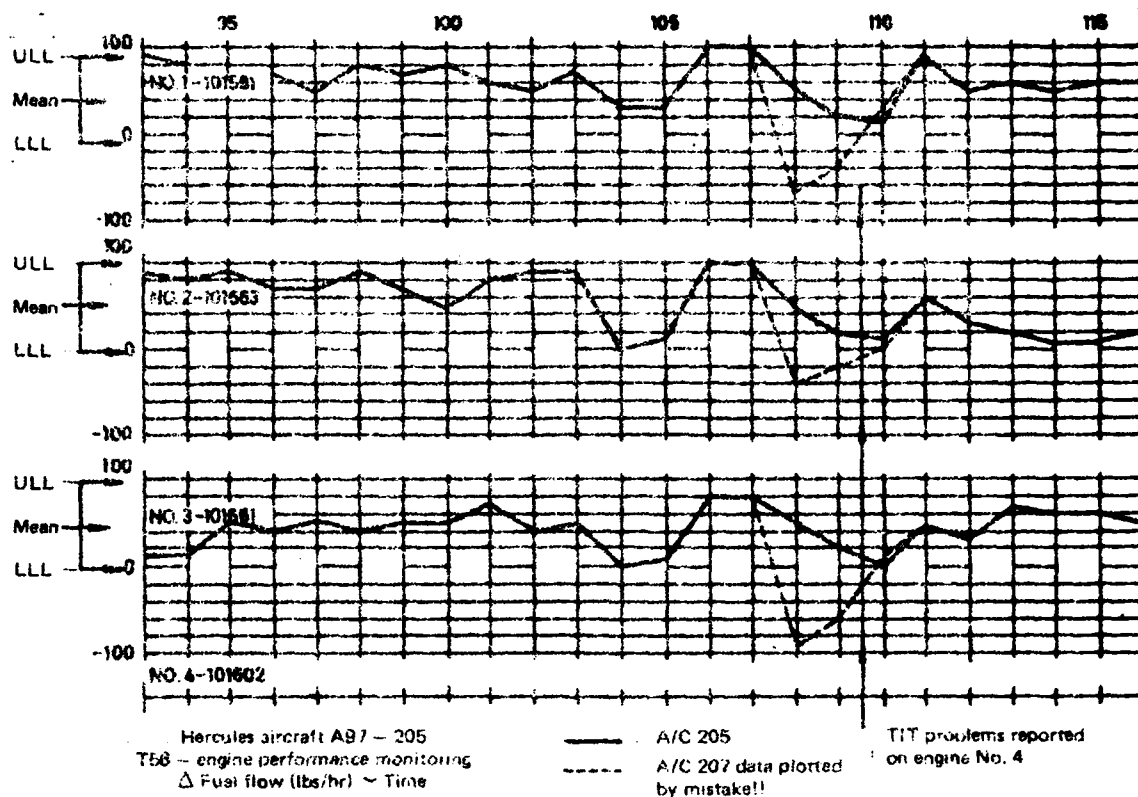
FIG. 6(a) FUEL FLOW TRENDS

Reference to the fuel flow and torque trends given in Figs. 6a and b for aircraft 205 shows marked deviations in these values between points 106 and 110 on all three engines: this behaviour is symptomatic of an indicating or control problem on the fourth engine. The diagnosis was confirmed by reference to the EE 500 which showed that the Temperature Datum amplifier and indicator were changed between points 109 and 110 on the No. 4 engine. Special note should be made of the dashed lines between points 107 and 111, examination of the raw data showed that these 3 points were associated with a different aircraft.

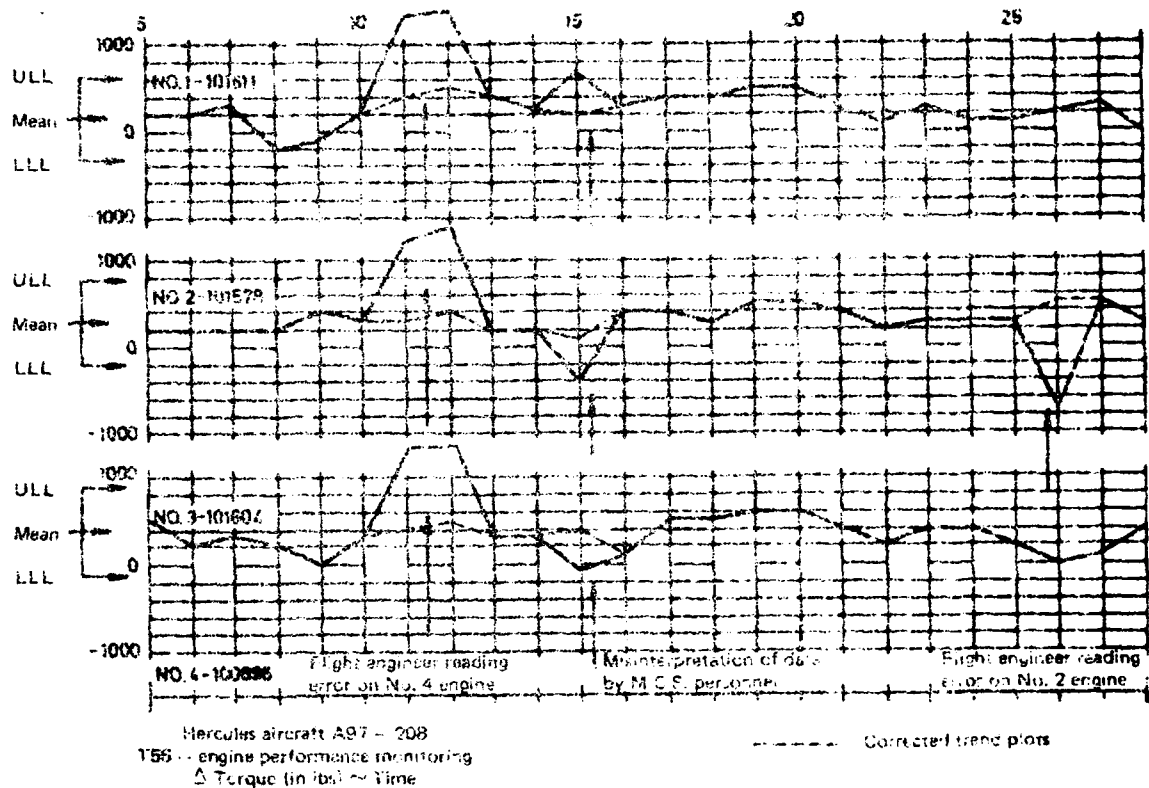
FIG. 7(a) TORQUE TRENDS

The torque and fuel flow trends given in Figs. 7a and 7b, for aircraft 208, show that there are at least four distinct changes in trend levels between points 5 and 45. On reference to the original data recorded by the flight engineer it was determined that the deviations at points 11-12 and at 26 in Fig. 7a were a direct result of a gauge reading error for the No. 4 and No. 2 engines respectively. The deviation at point 15 was attributed to a

misrepresentation of recorded data by personnel in the MCS. Corrected trend curves are indicated by the dashed lines in Fig. 7a. At this stage it must be stated that direct analysis and plotting of data in flight would obviate these problems. The other deviation observed between points 41 and 45 in Fig. 7b, was shown to be, on examination of the EE 500, a direct result of an unserviceable fuel gauge.

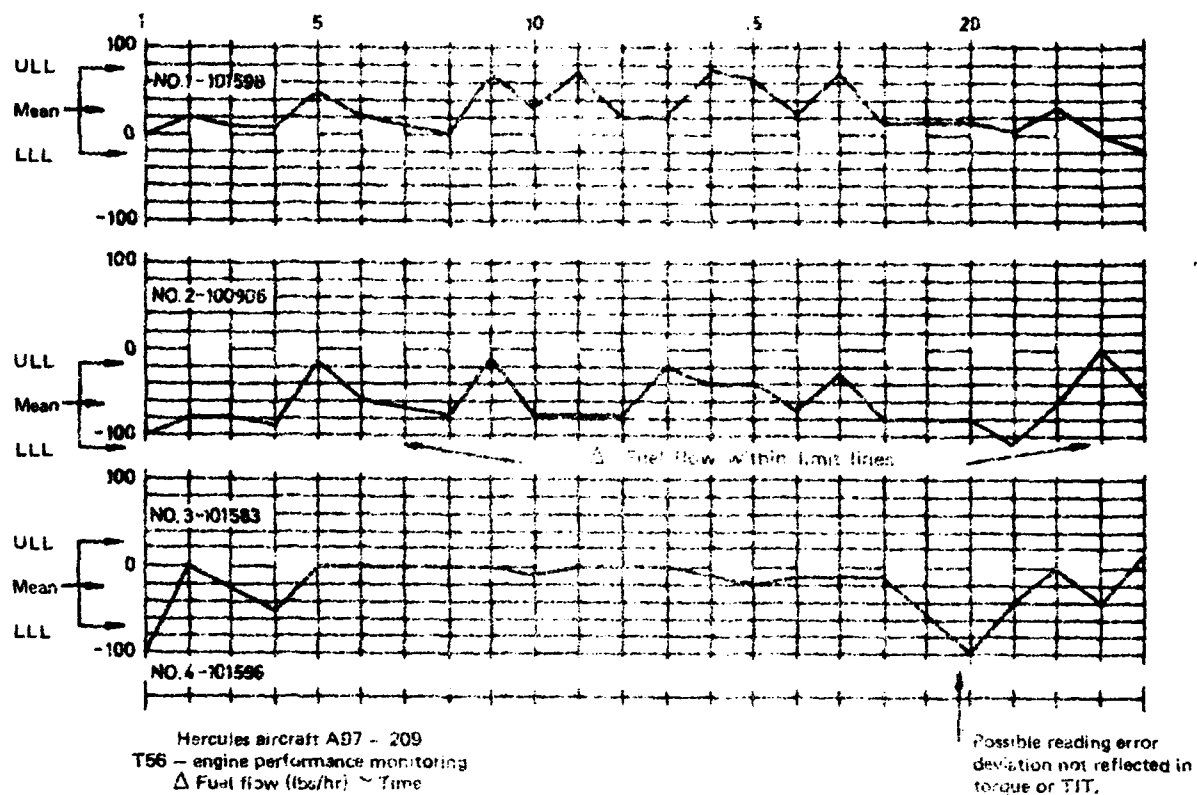
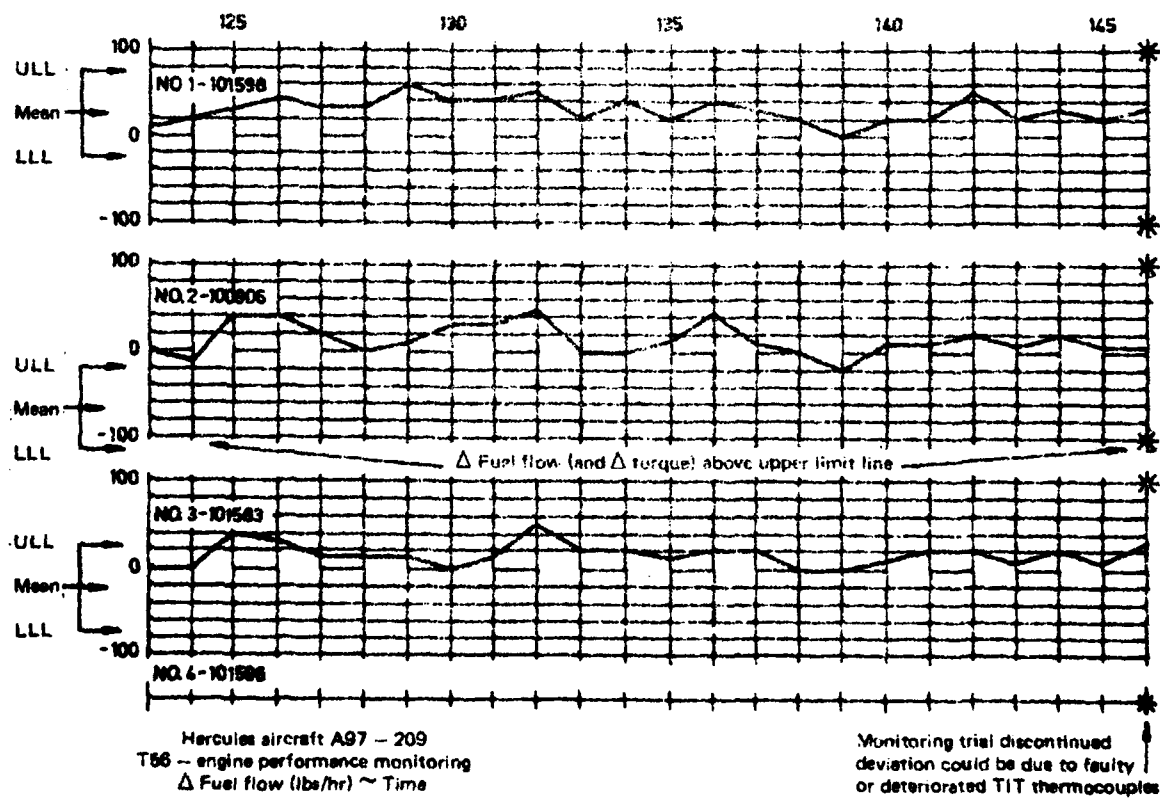
FIG. 8(a) & 8(b) FUEL FLOW TRENDS

Reference to Figs. 8a and 8b, for aircraft 209 shows that between points 1 and 146 when the monitoring trial was discontinued, there had been a gradual rise in the fuel flow for engine number 2 (a similar result was apparent for the torque trends) and from point 100 the trend lines were above the upper limit line. Analysis of these results suggests a serious deterioration of the thermocouples in the Turbine Inlet Temperature indicating system; examination of the EE 500 gives no reported indication of this malfunction. Further investigation, in an endeavour to isolate the cause has revealed that the aircraft and the engine had been withdrawn from service prior to disposal.

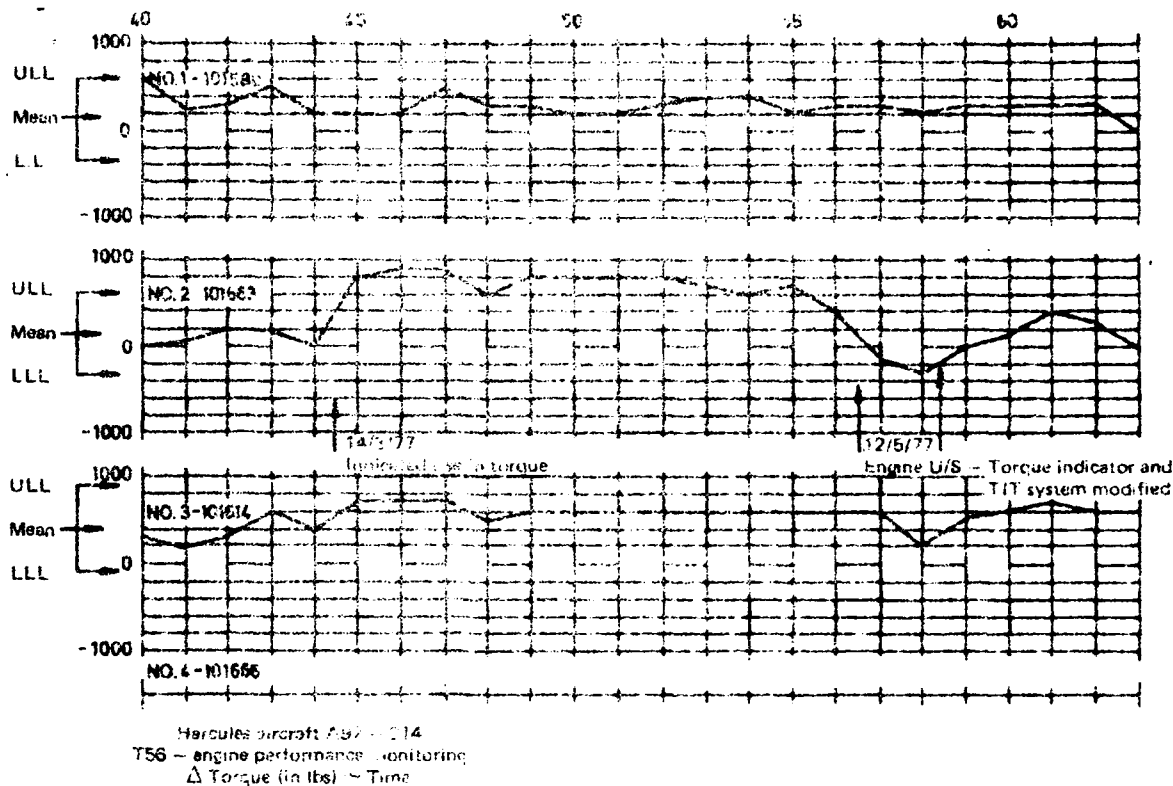
FIG. 9 TORQUE TRENDS

Reference to Fig. 9, shows that a sudden increase in torque level, for engine number 2, occurs at point 45, this increase is maintained up to point 58 after which the torque trend returns to its previous level. Analysis of the EE 500's shows that the torque indicator and TIT system was modified between points 56 and 58. It is perhaps relevant to note that this particular fault was indicated by the trend plots some four weeks before maintenance action was initiated.

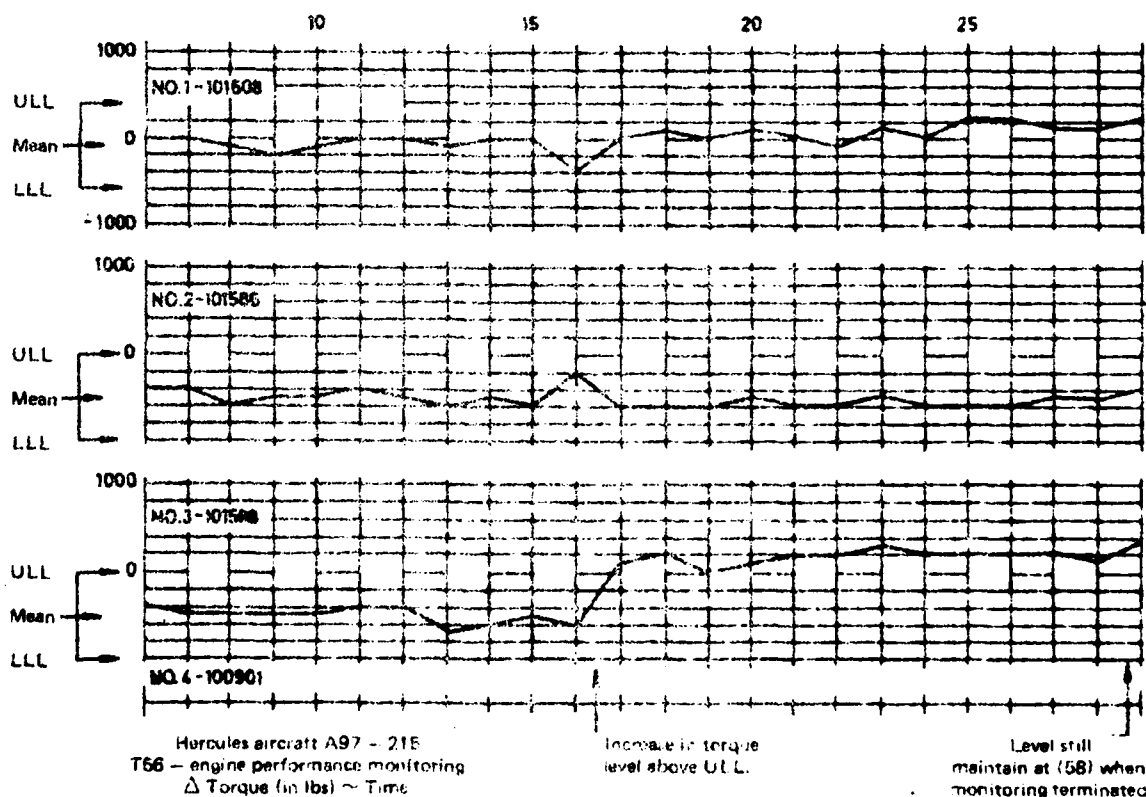
FIG. 10 TORQUE TRENDS

The torque trend for engine number 3, as given in Fig. 10, shows a sudden increase in levels at point 17, which was maintained until the monitoring of performance trends was discontinued. No explanation for the changes in levels can be ascertained from the EE 500's and it is thought that, as with A97-214, it could be an unrecognised fault in the torque or TIT indicating system.
